*After the current voyage she was heading for Singapore in ballast, where she was needed urgently by her charterers, a major international oil company. So the decision was made. In Singapore, where tide and water conditions were favourable, she would have her propeller removed afloat, and replaced by the spare carried aboard*

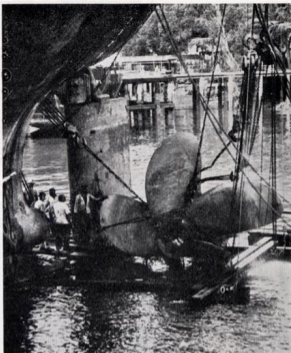
*Lying alongside the Port of Singapore Dockyard jetty, Hector Heron was trimmed by the head. With the shaft clear of the water (picture 1, facing) wire snotters were attached to bits on the poop and led over the side to chain blocks. The propeller was lashed with wire ropes and these ropes attached to the chain blocks (picture 2, facing). The weight of the propeller (17.4 tons) was taken on the blocks and the propeller boss and locking nut removed. The tail shaft was then drawn inboard and the propeller (picture 3, right) swung aside and ashore by a dockyard crane, ready for replacement*

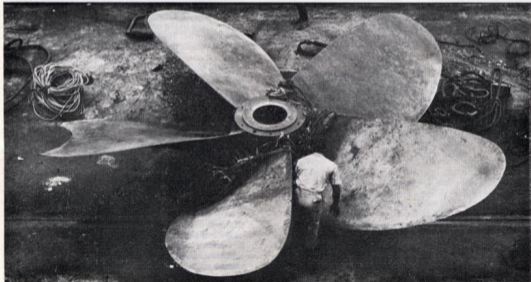
*The damage to the five-bladed propeller is clearly seen in picture 4, taken on the jetty. Our back cover picture shows conditions facing Port of Singapore Authority workers as they completed the rush job on March 22 and 23*
